Manhole Inspection Summary

Manhole # S31K1_012MH

Insp Date: **3/19/08 1:25 PM**

Location Address: **2513 Seamon Avenue**

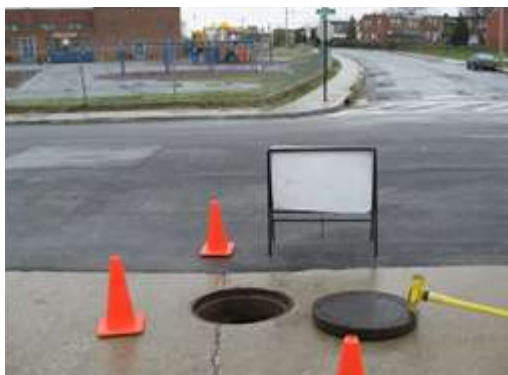
Location View

2513 Seamon Ave.

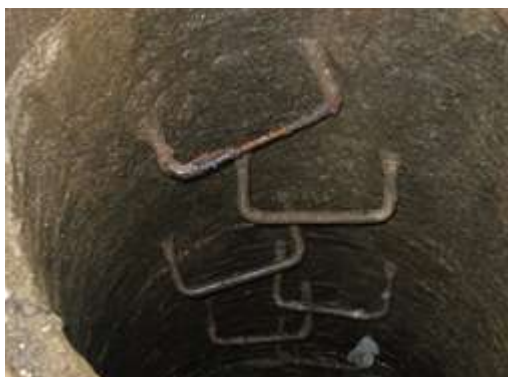
Steps Count: **7** Missing: **0** ☒ Corroded

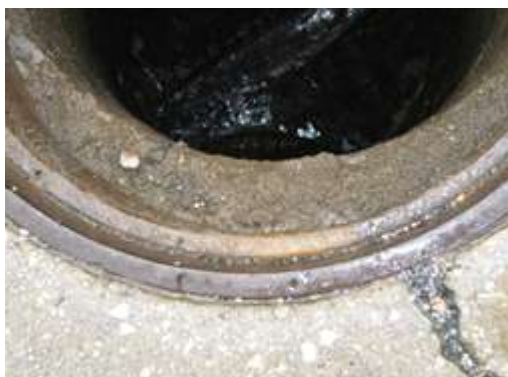
Defect 1

Frame Offset: **3** (in.) Condition: ☒ Sound ☐ Cracked ☐ Leaks

Frame offset

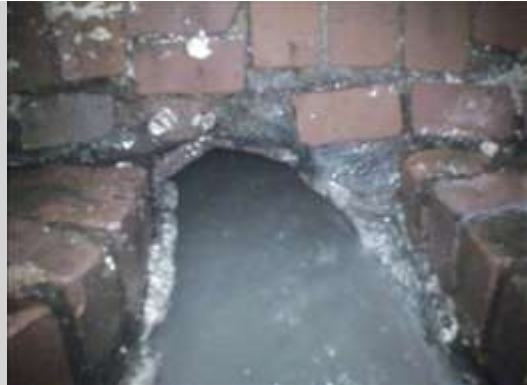
12 O'Clock Outflow

8 in. Circular Gravity Sewer
Pipe Out @ 12 O'Clock

Pipe Height: **8.4** (in.) Rod and Bar (Angled)
Pipe Material: **Clay** ☐ Pipe Lined
Invert Depth: **12.62** (ft.) Flow Characteristics: **Fast**
Deposits: ☒ None ☐ Mud ☐ Sludge ☐ Debris ☐ Grease
Silt Depth: (in.) Deposits Extent:
Infiltration: **None** Pipe Seal Cond: **Sound**

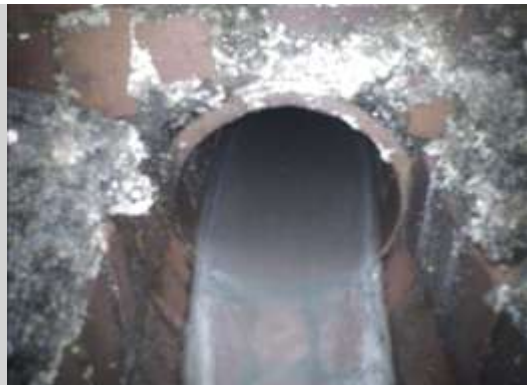
6 O'Clock Inflow

8 in. Circular Gravity Sewer
Pipe In @ 6 O'Clock

Pipe Height: **8.4** (in.) Rod and Bar (Angled)
Pipe Material: **Clay** ☐ Pipe Lined
Invert Depth: **12.24** (ft.) Flow Characteristics: **Fast**
Deposits: ☒ None ☐ Mud ☐ Sludge ☐ Debris ☐ Grease
Silt Depth: (in.) Deposits Extent:
Infiltration: **None** Pipe Seal Cond: **Sound**

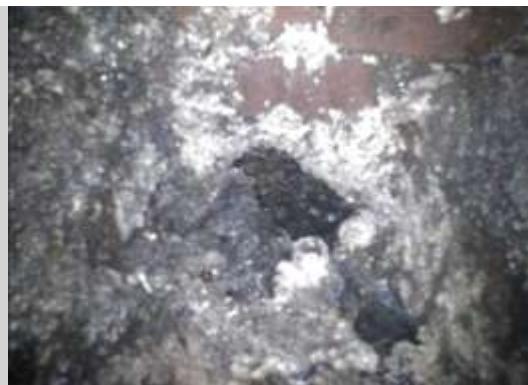
8 O'Clock Inflow

6 in. Circular Service Sewer
Pipe In @ 8 O'Clock

Deposits: ☐ None ☐ Mud ☐ Sludge ☐ Debris ☒ **Grease**

Silt Depth: **5** (in.) Deposits Extent: **Medium**
